Demonstration and Validation of a High-Performance Floor-Sealant System to Reduce Concrete Degradation

Final Report on Project F10-AR02

Under Project F10-AR02, "Application of an Innovative, High Performance Concrete
Floor Sealant at Hunter Army Airfield, Georgia"

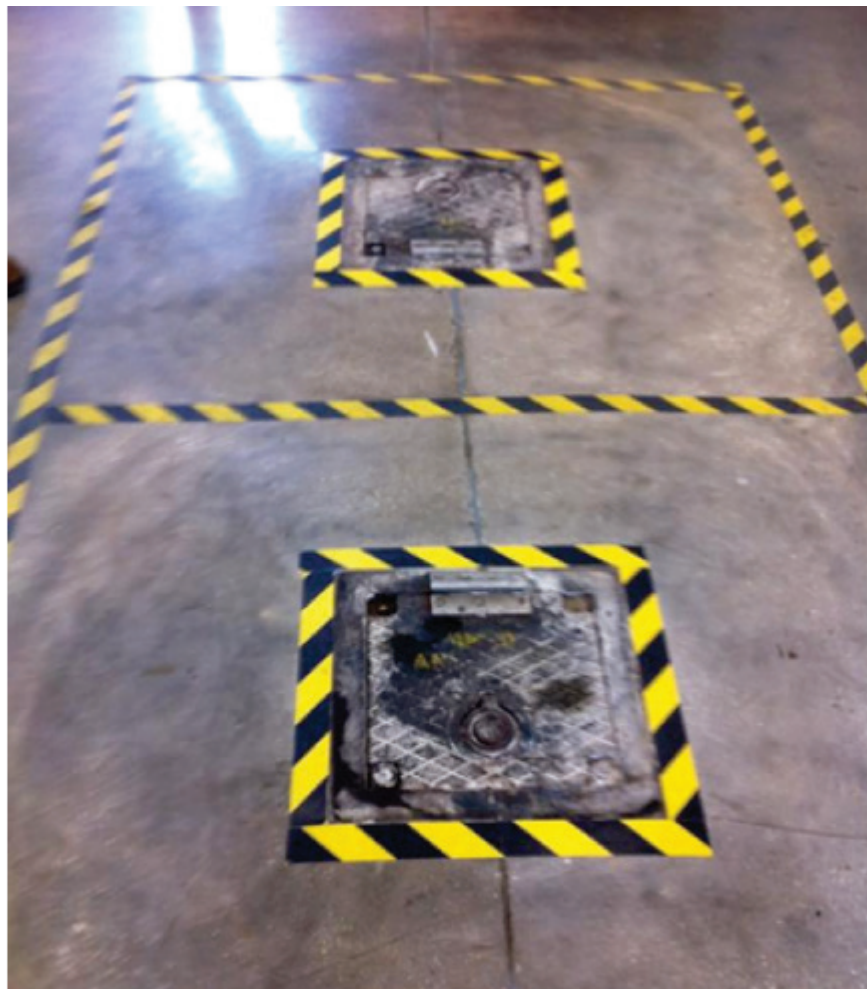
This inspection was performed in conjunction with a site visit scheduled by project team personnel to apply safety striping tape to vehicle bay floors. Stripes are needed around electrical junction boxes, which are installed in raised sections of the vehicle bay floor (Figure 22). Safety striping is normally painted on concrete floors, but tape was used because striping paint would not adhere to the sealed surfaces. At this same time, the treated floor surfaces were assessed, and no sealant deficiencies were noted.

Figure 22. Safety striping tape marking junction boxes on floor.

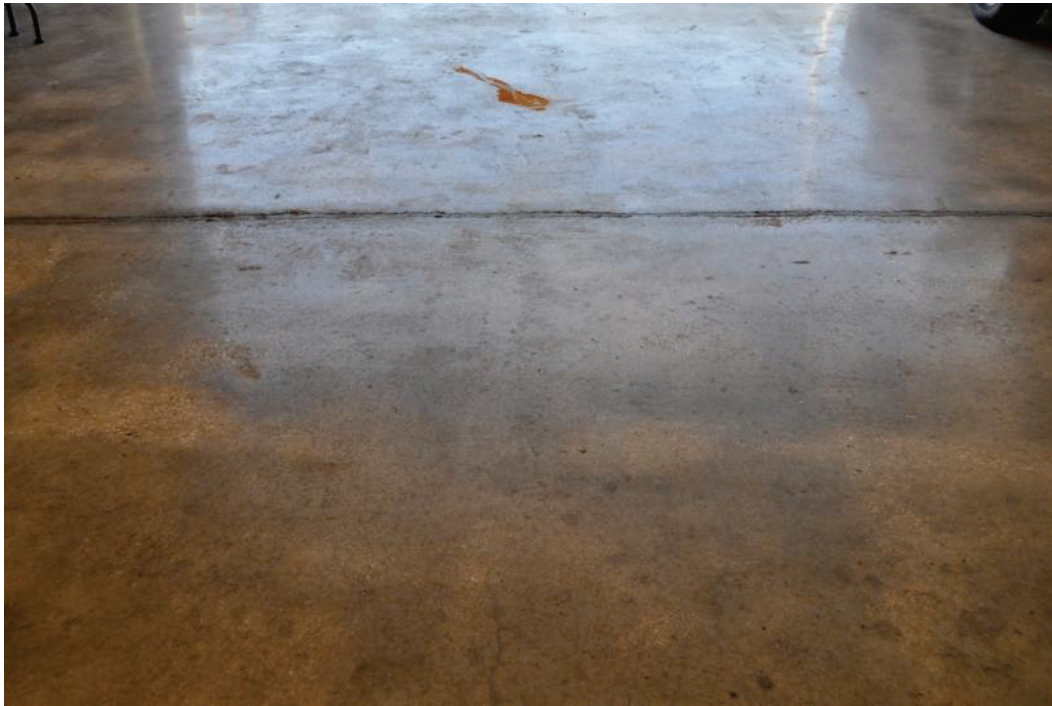
The floors continued to look good overall without much degradation since the previous assessment. Personnel continued to express satisfaction with the ease of cleaning the floors. However, some problems related to the concrete repairs and floor-joint seals in the maintenance bays were still evident. Also, repairs made to floor crack in the hallway continued to deteriorate. A patch applied to repair some spalled concrete on the maintenance bay floor had come off. There was an area of deteriorated floor finish that appears to have been caused by a spill, and minor stains were noted in a few places. The overall floor appearance remained good (Figure 23).

Figure 23. General floor condition at 9 months.

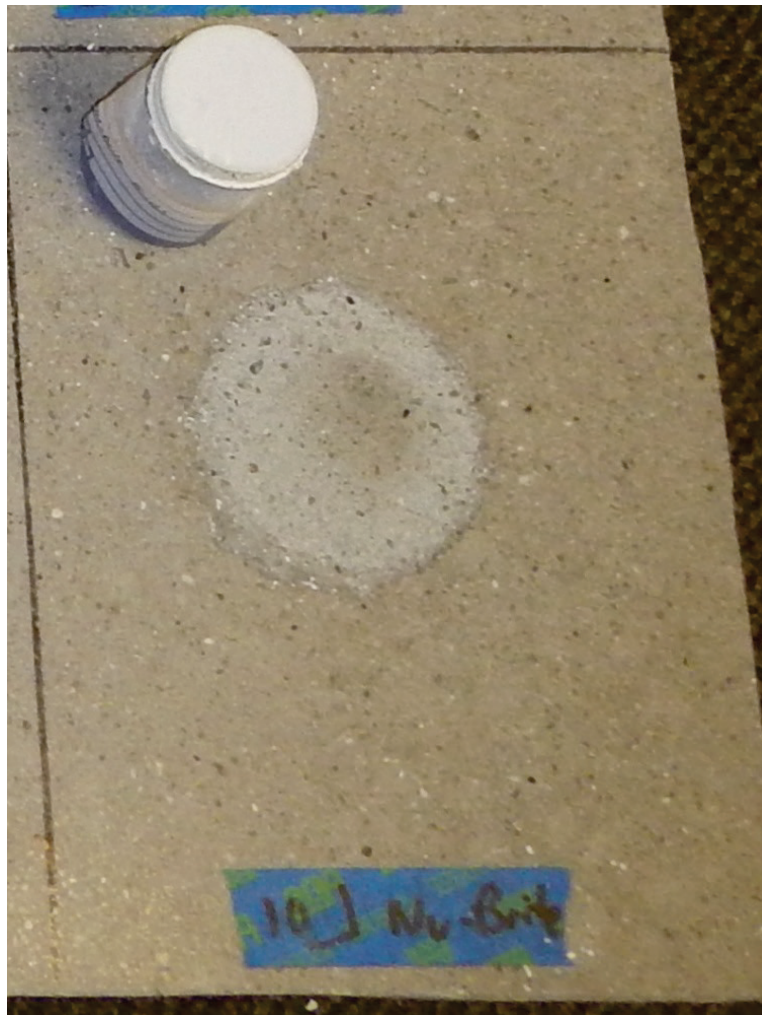
Figure D24. Test 10–Nu-Brite alkaline coil cleaner.

Only one material—Nu-Brite Alkaline Coil Cleaner—had any damaging effect on the Pentra-Sil® 244+ and Pentra Guard® (HP) surface sealant system. This caustic chemical defeated the sealant system and physically etched the polished concrete surface.
